Acoustic Consultant:	Nagata Acoustics
Architect:	Isozaki + HuQuian Partners
Owner / User:	Shanghai Symphony Orchestra
Construction Cost:	RMB 630 Million

SHANGHAI SYMPHONY HALL

SHANGHAI, CHINA
2014

NAGATA
ACOUSTICS

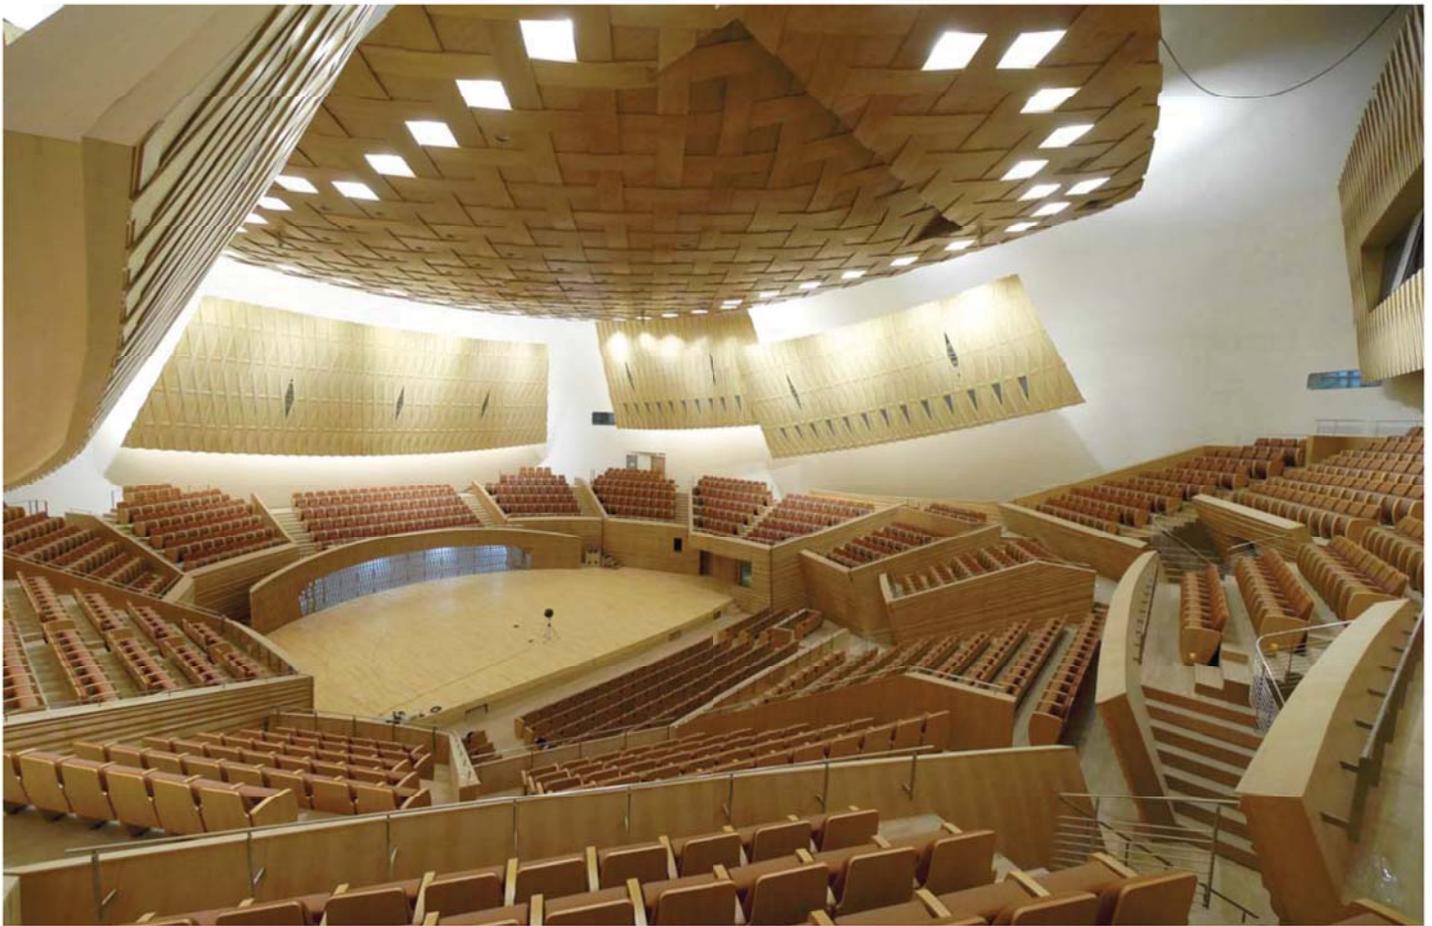
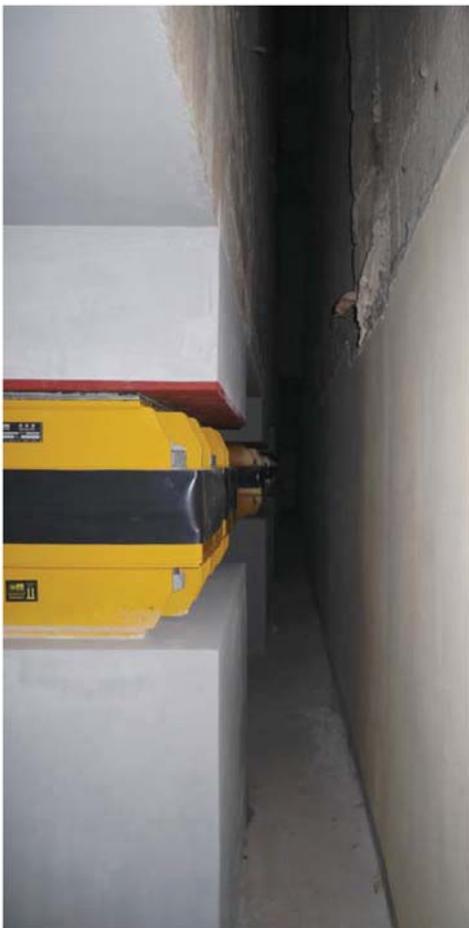
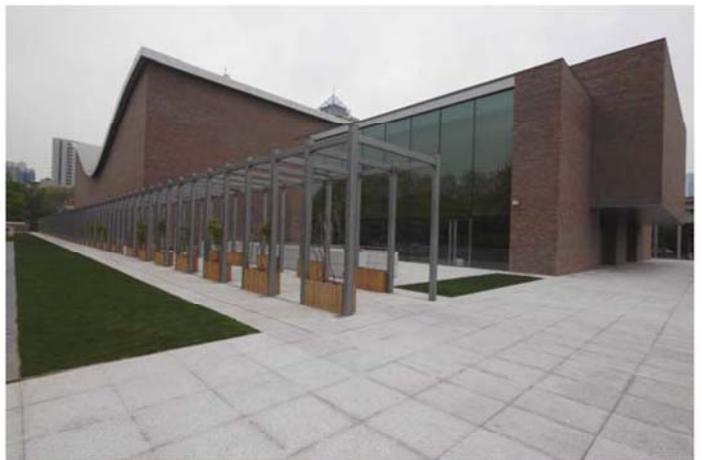
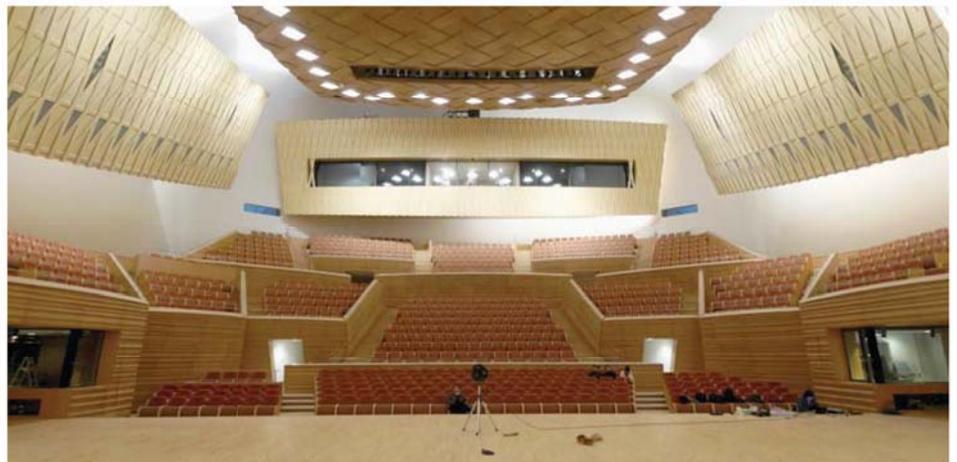
Clockwise from Top:

- Hall Overview
- Hall and Lobby Facade
- Main Audience
- Structural Isolation Springs and Isolation Joint
